PILT 1010 Air Transportation

November 1, 2012

## Hughes Airwest DC-9 vs. U.S. Marine Corps F-4B

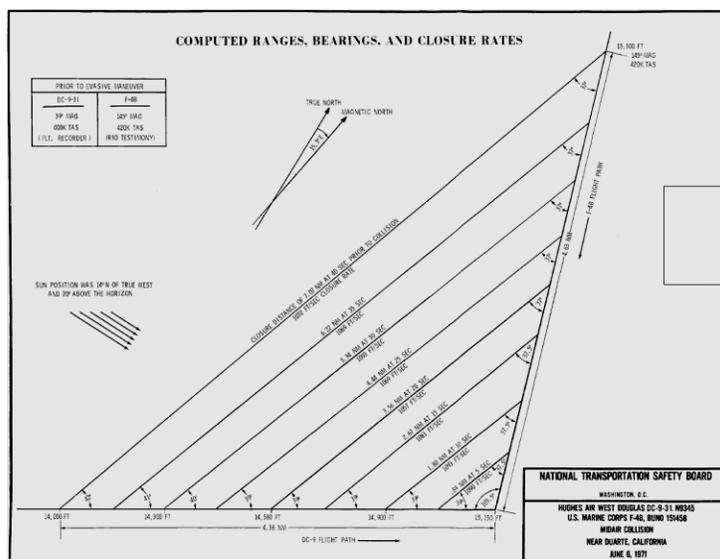
While approaching Bakersfield Flight Service Station, Phillips and Schiess decided to stray east from the designated flight plan to evade heavy air traffic near Los Angeles. The crew was forced to climb over 14,500 feet in altitude, from 1,000 feet to 15,500 feet because of worsening weather conditions. Meanwhile, Flight 706 had been given two radar traffic advisories, neither of which displayed any sign of the '458'. Shortly after the fighter reached the elevation needed to elude bad weather, its Distance Measuring Equipment (DME, i.e. radar) showed that MCAS El Toro was approximately 50 miles away. Because of the design of the aircraft, the pilot then executed an aileron roll, where he rolled the aircraft 360°, to be able to see any sign of air traffic above or below the aircraft as they were approaching. Schiess spotted the DC-9 in his peripheral vision between three and ten seconds prior to the collision, while looking at the radar, (on which no aircrafts were detected due to its failing condition) and hollered a warning to Phillips. Phillips attempted an evasive roll but unfortunately, was unable to clear the oncoming airliner. After the two aircrafts collided, the DC-9 “cart-wheeled” through the air, crashed into a mountain and exploded, killing all onboard; the F-4B then crashed in to Mount Bliss, roughly one mile from the airliner wreckage, killing the pilot. The only person spared from a horrific death was 1<sup>st</sup> Lieutenant Schiess, who was able to eject and parachute to safety.

Closing diagram of Airwest DC-9 and F-4 Phantom near Duarte, CA. Source: NTSB accident report.
