PILT 1010 Air Transportation

November 1, 2012

## Hughes Airwest DC-9 vs. U.S. Marine Corps F-4B

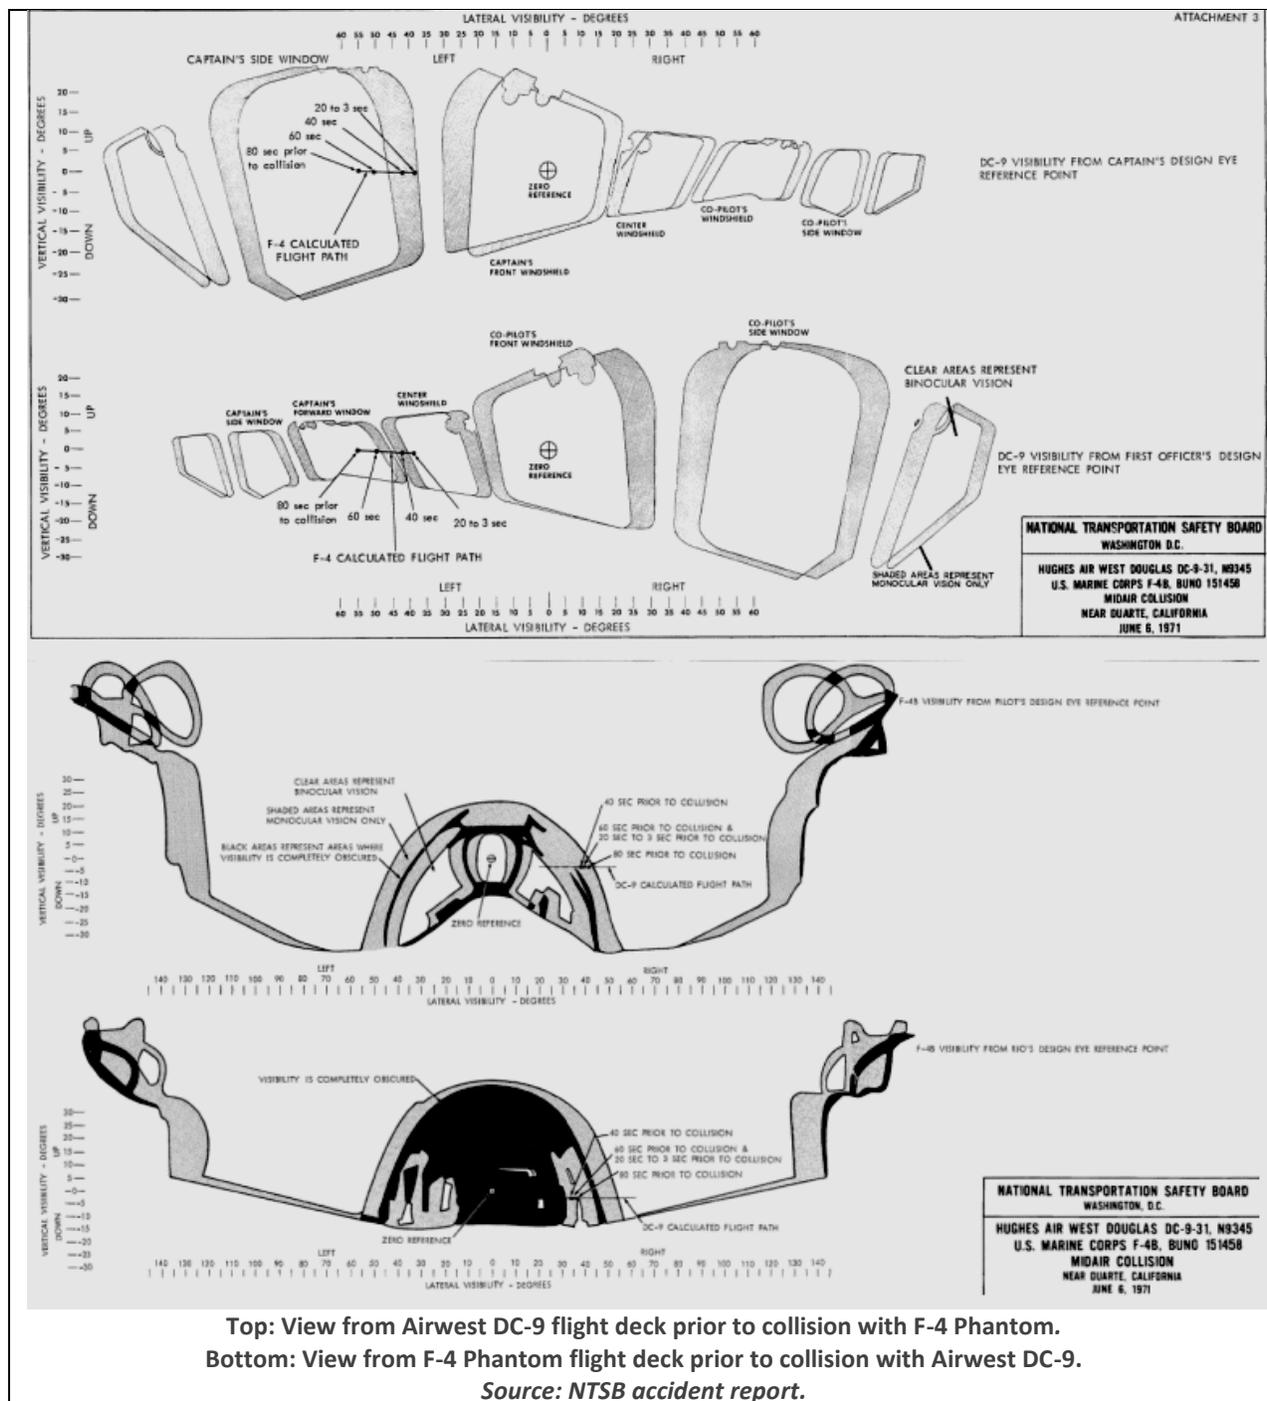
Exploration of the incident exposed what happened in the final moments of the tragic accident and the series of events that led up to it. It appeared that the Phantom came into contact with the airliner in two places: First, with its left wing impacting the forward passenger cabin and the vertical stabilizer slicing through the cockpit. It was calculated that just an additional ten feet of clearance would have averted the entire collision. The initial inspection found nine bodies
